**Enbridge Line 6B MP 608 Pipeline Release
Marshall, Michigan**

**Permanent Recovery of Submerged Oil and Oil-Contaminated
Sediments at Priority Locations**

Submerged Oil Recovery Summary Report

**Enbridge Energy
October 29, 2010**

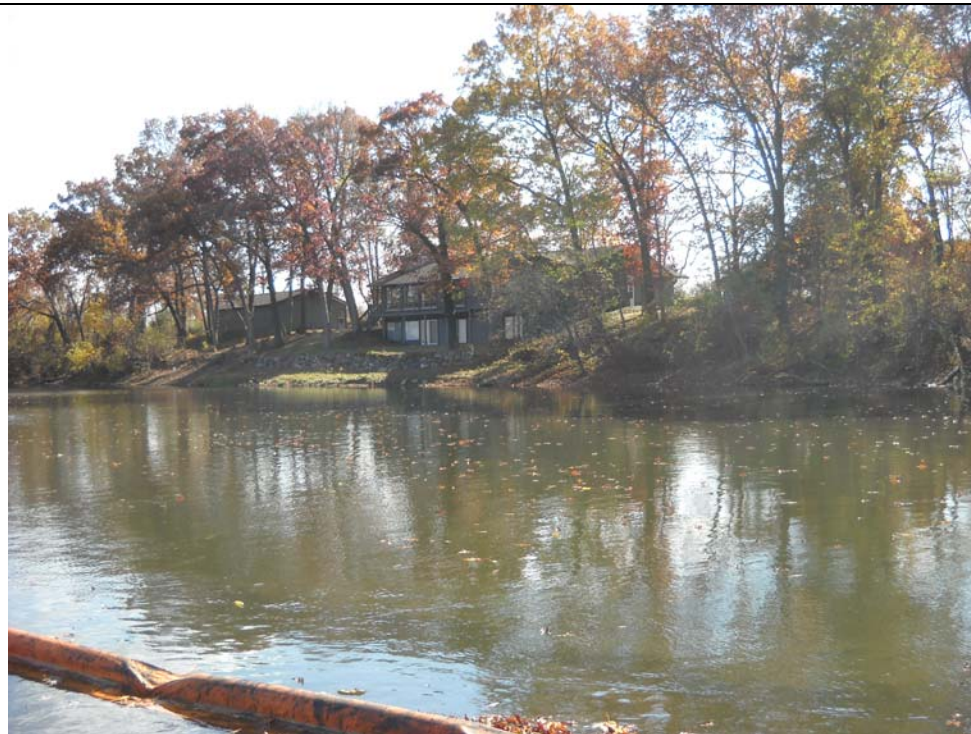
**PHOTOGRAPH LOG**
Photograph 6

Description:
Recovery activities
complete – dredging
completed

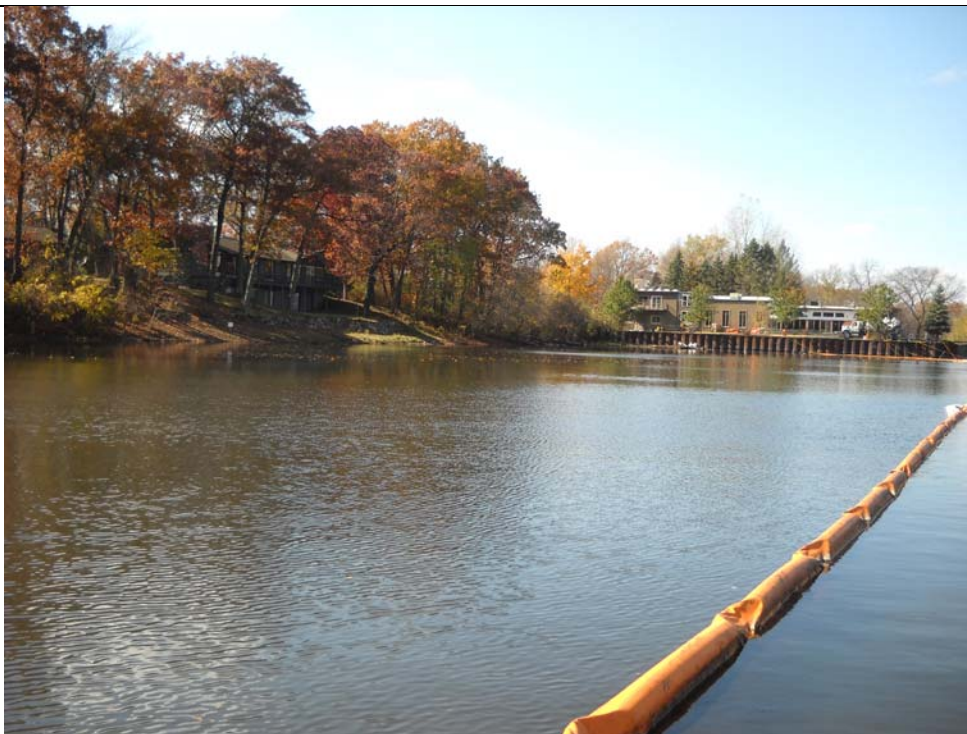
PHOTOGRAPH LOG
Photograph 7

Description:
Recovery activities
complete – dredging
completed

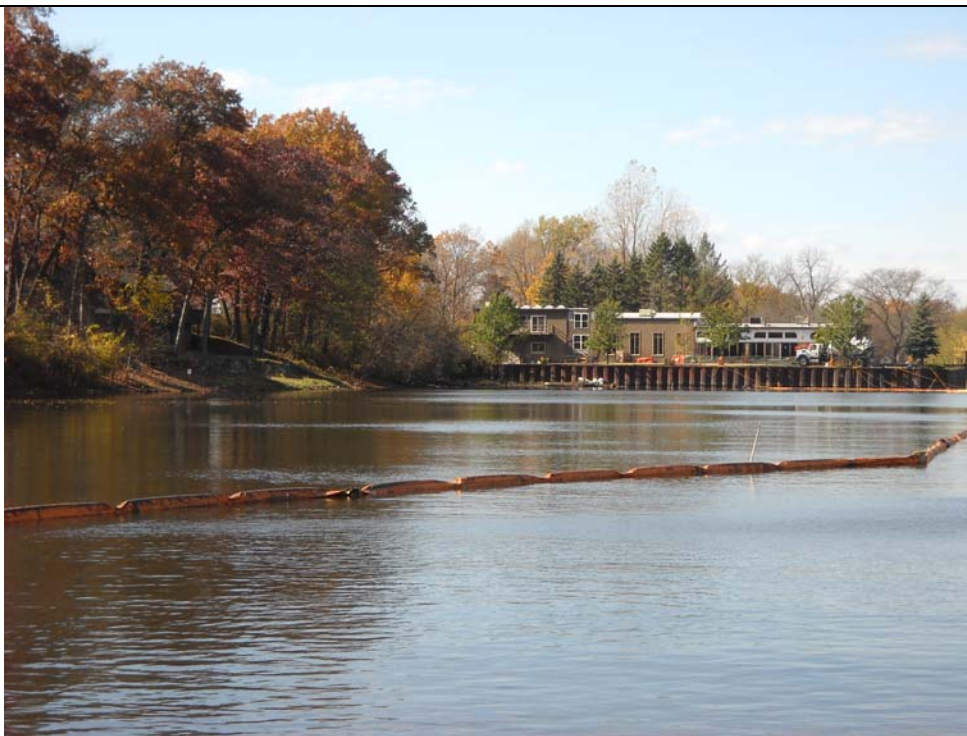
**PHOTOGRAPH LOG**
Photograph 8

Description:
Recovery activities
complete – dredging
completed

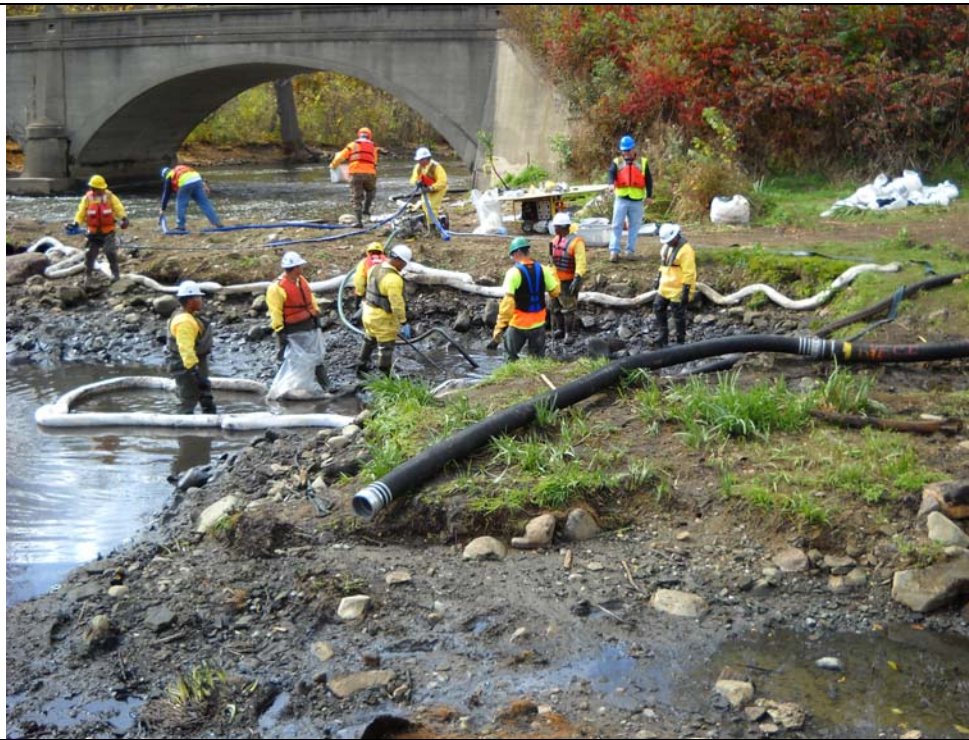
Photograph 2

Description:
Recovery activities in progress – pumping down water area

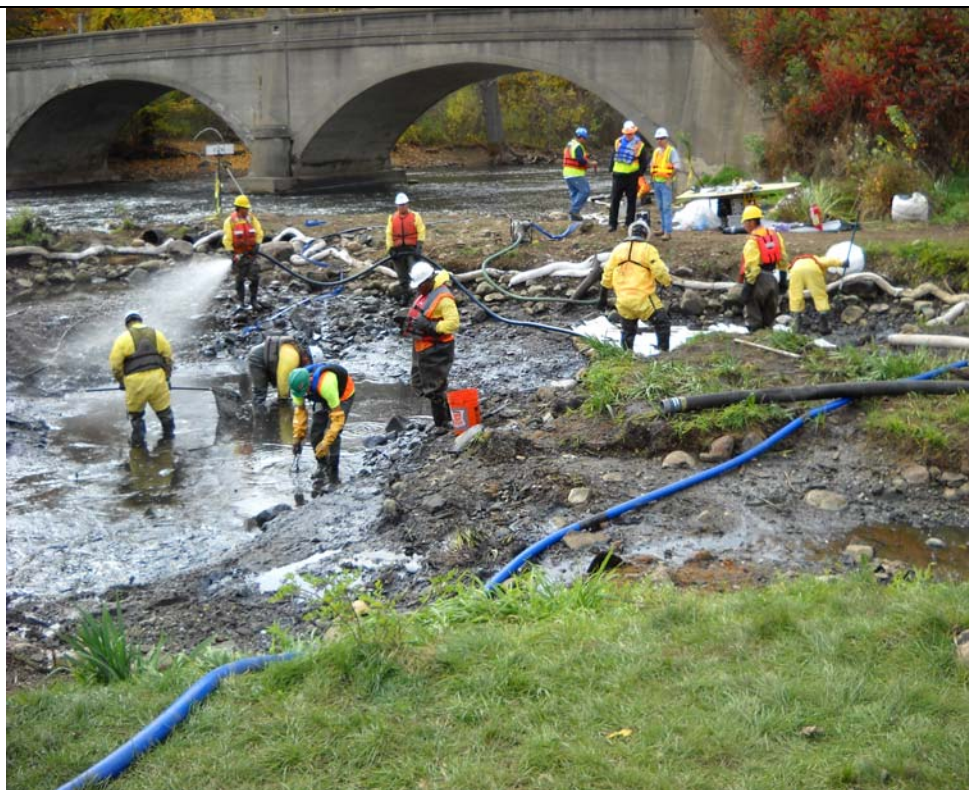
Photograph 3

Description:
Recovery activities in progress – pumping and water washing

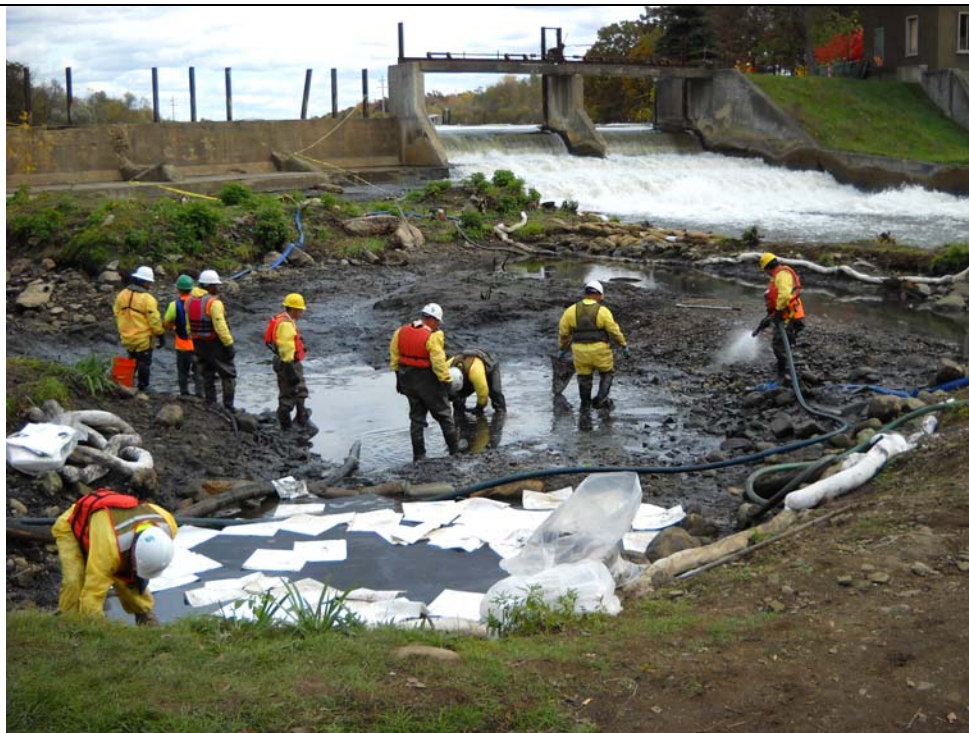
Photograph 4

Description:
Recovery activities in progress – boom and pad deployment and power washing

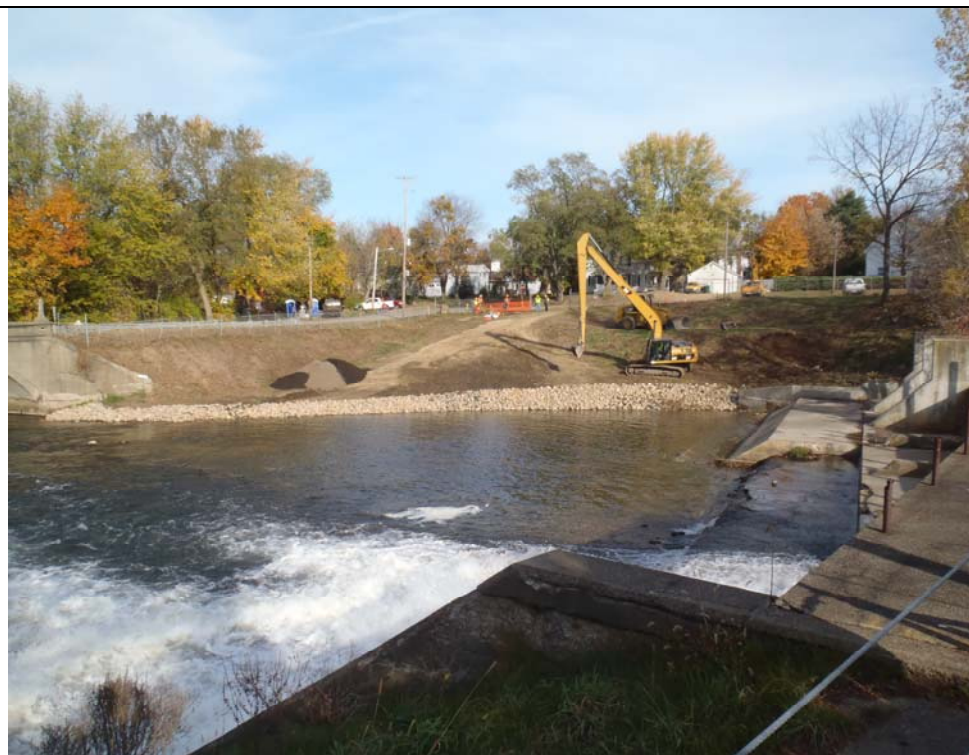
Photograph 5

Description:
Post Recovery Activities in progress – grading side of bank after sediment removal

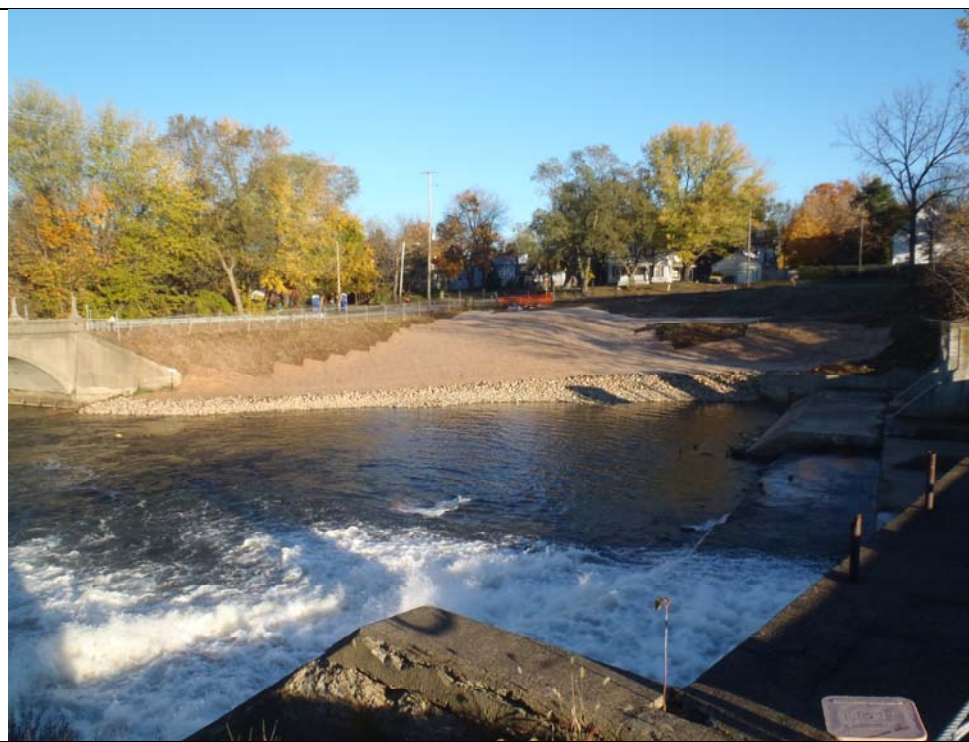
Description:
Post Recovery activities complete – site restored

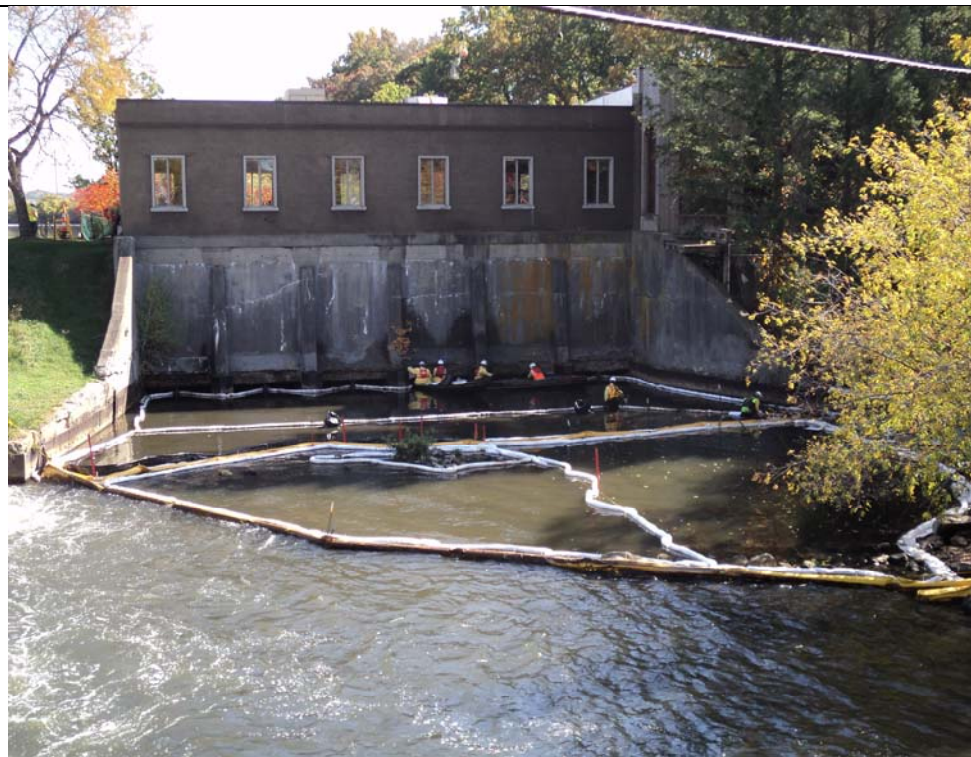
Description:
Recovery activities in
progress – power washing

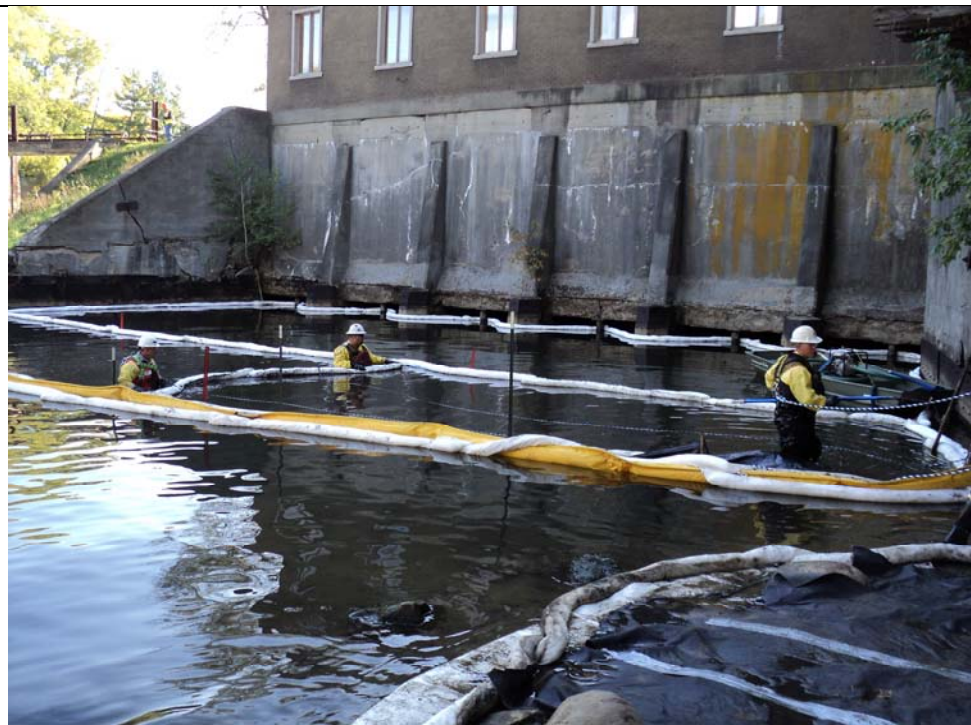
Photograph 2

Description:
Recovery activities in
progress – power washing

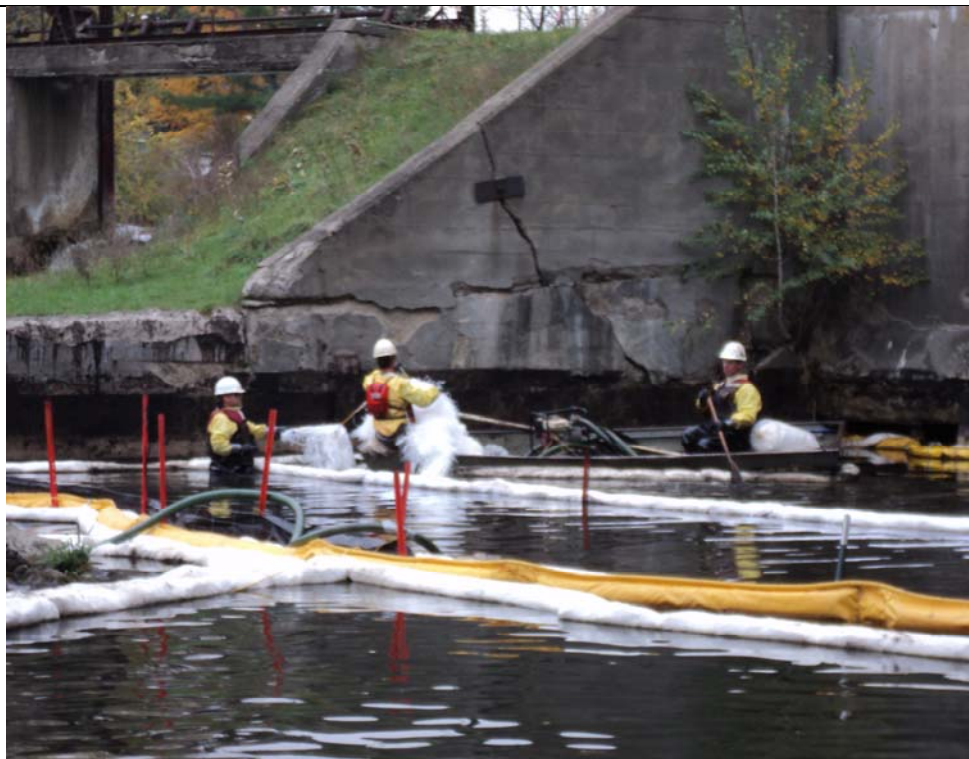
Photograph 3

Description:
Recovery activities in
progress – power washing

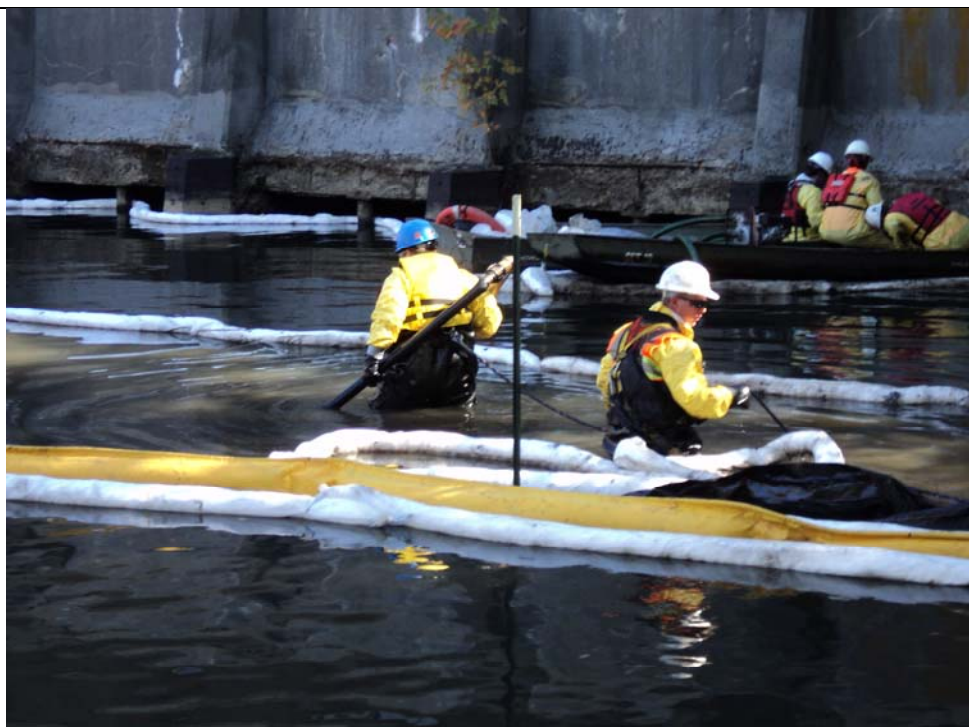
Description:
Recovery activities in
progress – power washing

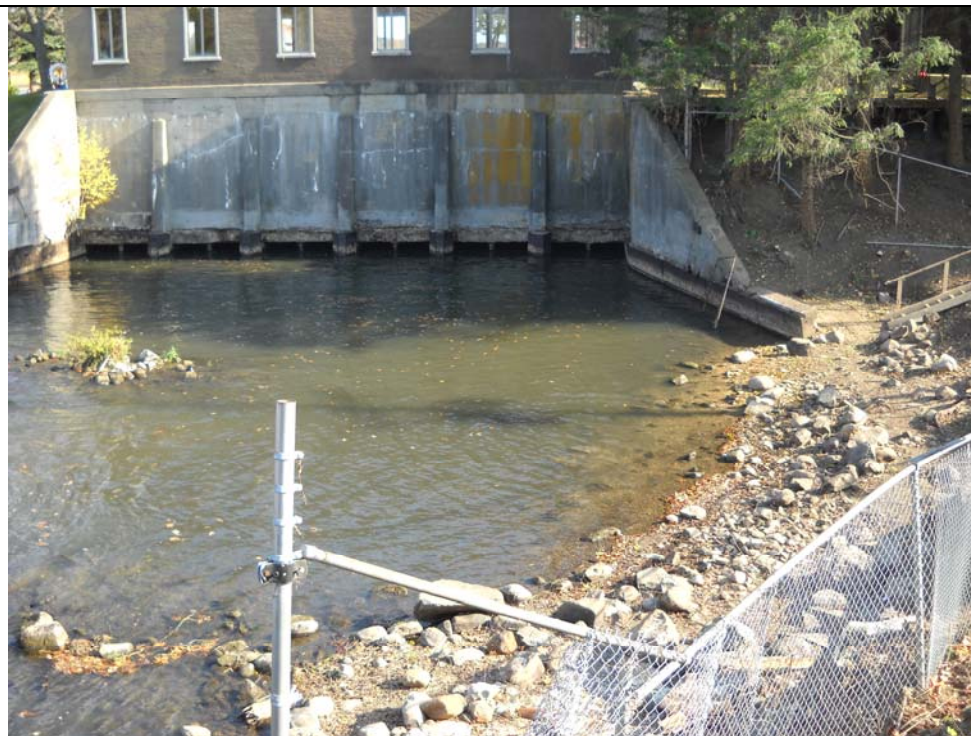
**PHOTOGRAPH LOG**
Photograph 6

Description:
Post Recovery – Activities
complete and containment
removed

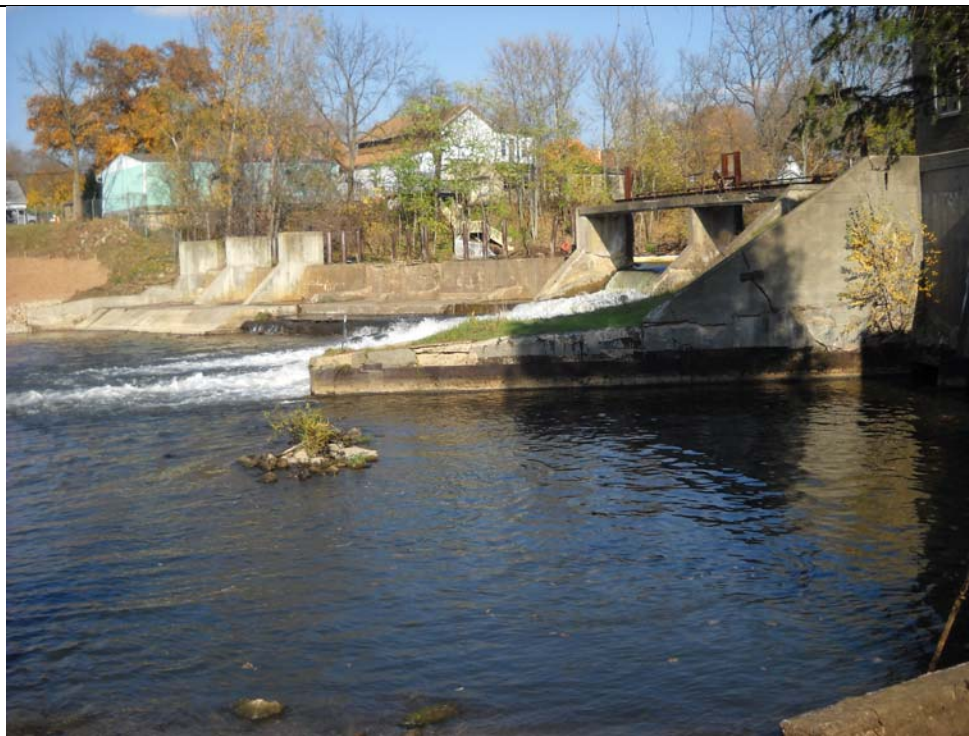
Photograph 7

Description:
Post Recovery – Activities
complete and containment
removed

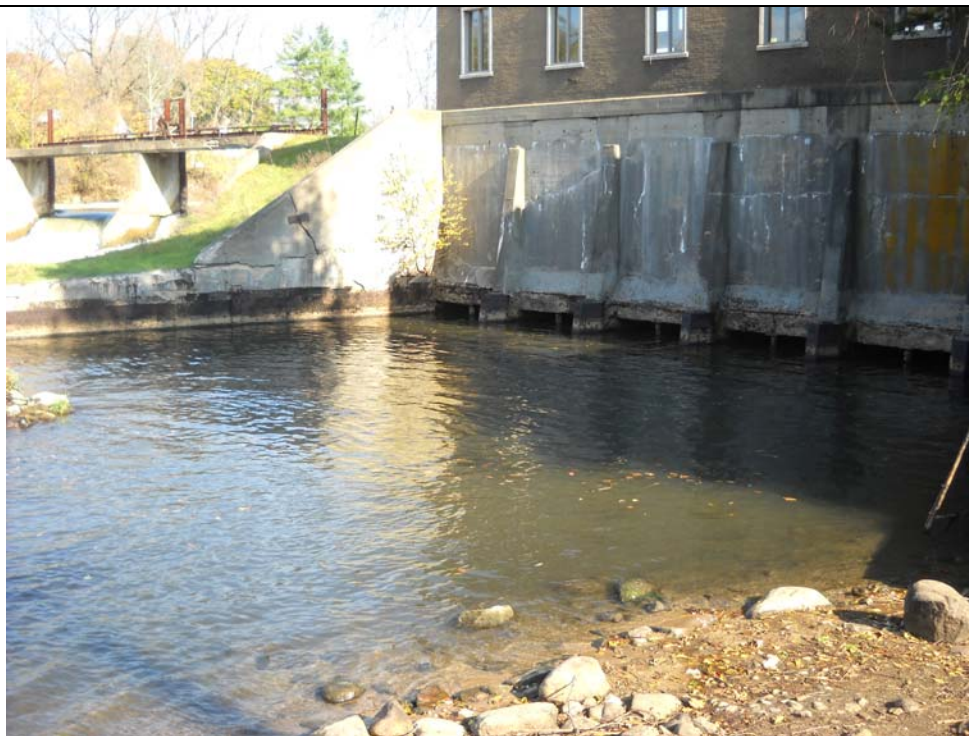
Photograph 8

Description:
Post Recovery – Activities
complete and containment
removed

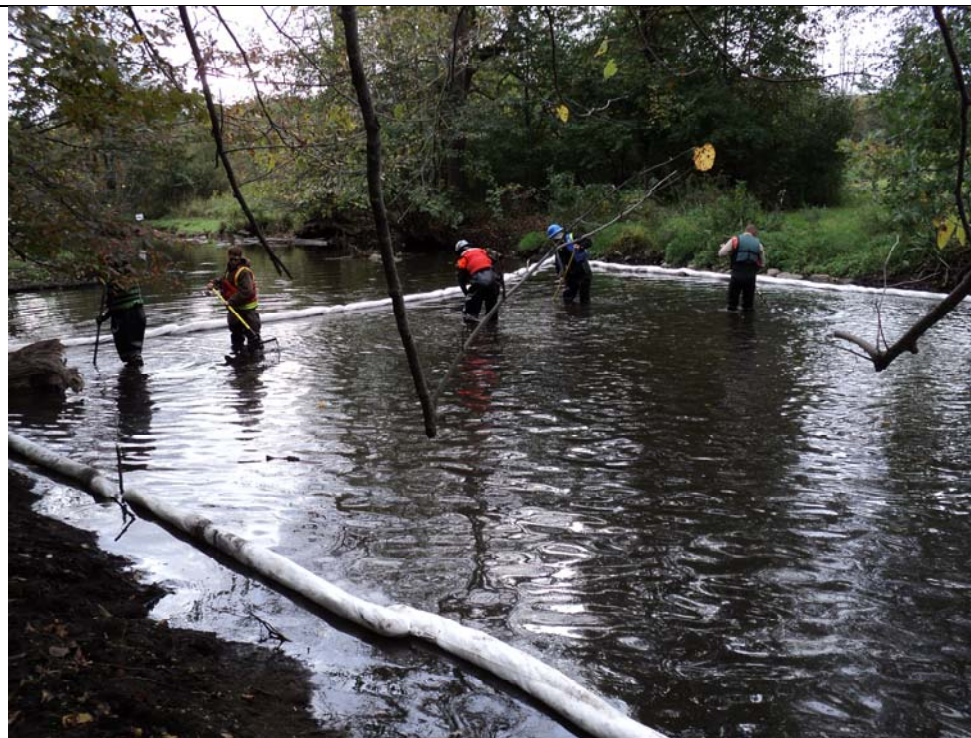
Description:
Recovery activities in
progress - raking

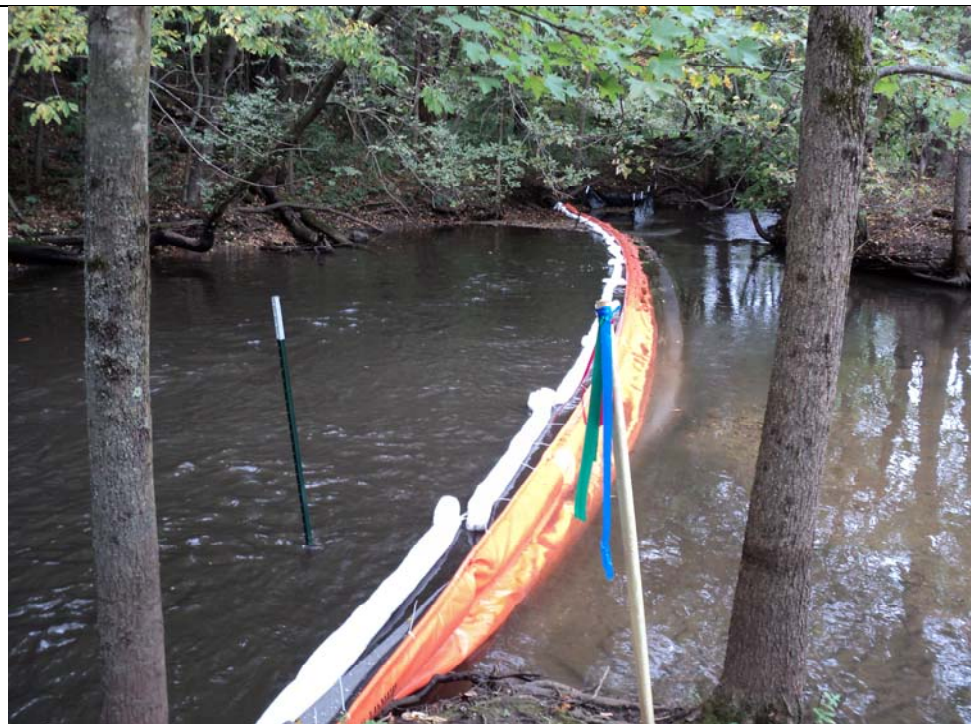
Photograph 2

Description:
Recovery activities in
progress - hard and soft
boom layout

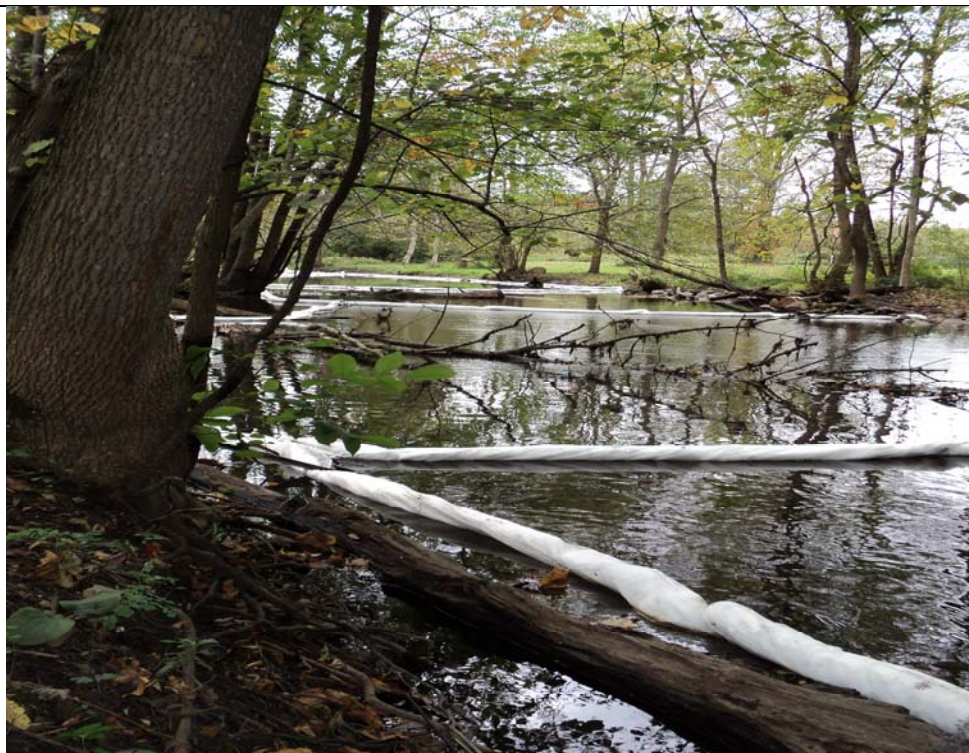
PHOTOGRAPH LOG
Photograph 3

Description:
Recovery activities in
progress – boom layout
and cell preparation

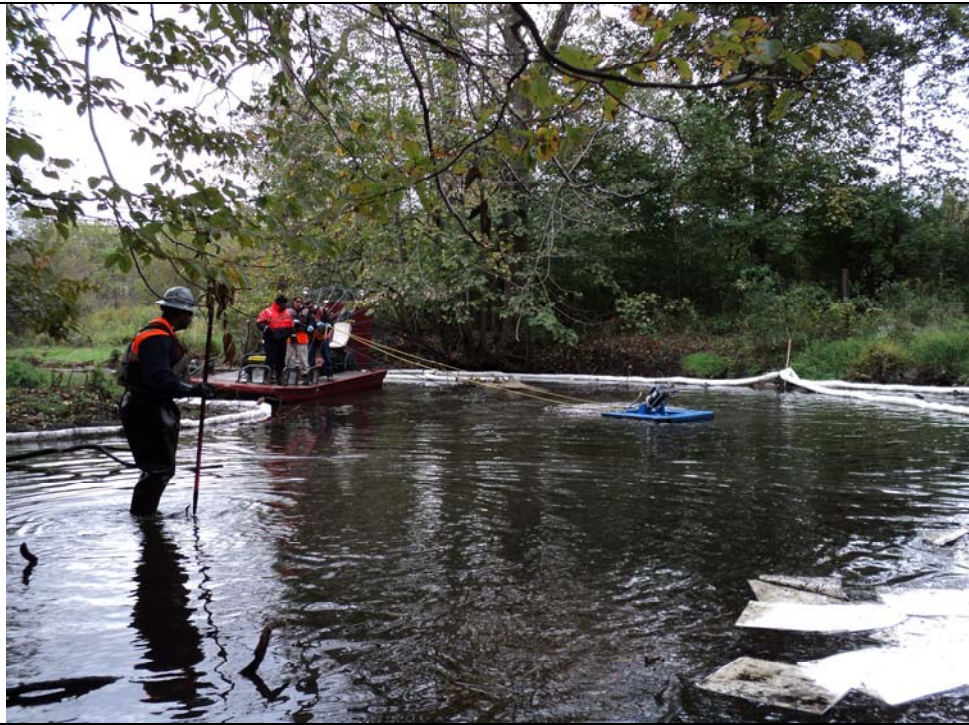
**PHOTOGRAPH LOG**
Photograph 4

Description:
Recovery activities in
progress - aeration

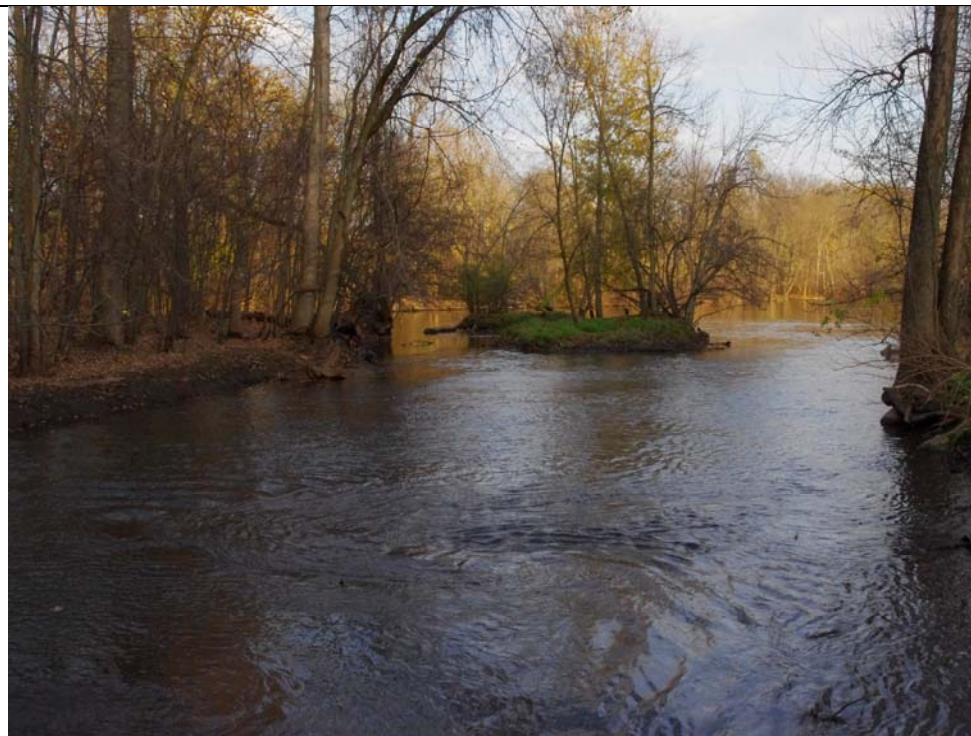
PHOTOGRAPH LOG
Photograph 5

Description:
Post Recovery conditions
– recovery actions
complete and containment
removed

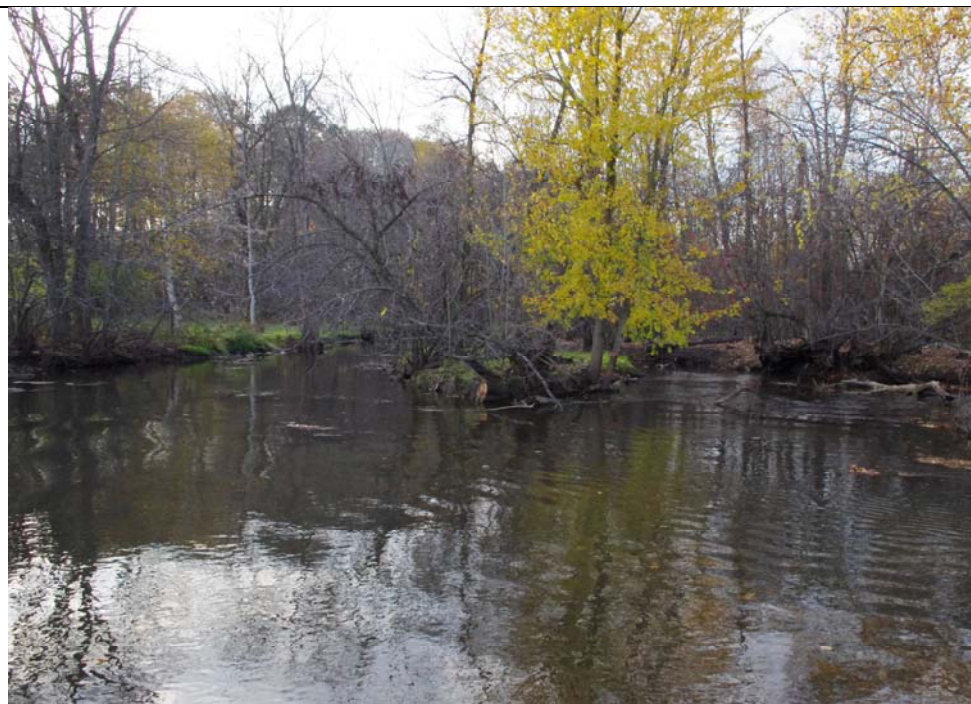
**PHOTOGRAPH LOG**
Photograph 6

Description:
Post Recovery conditions
– recovery actions
complete and containment
removed

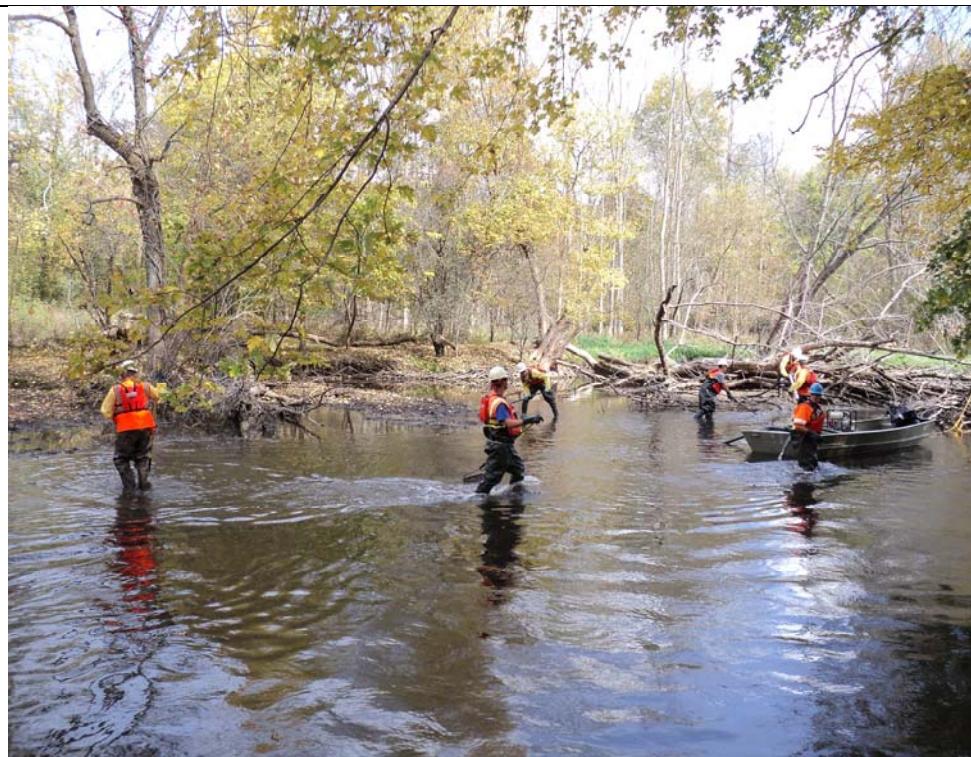
Description:
Recovery activities in progress - raking and water washing

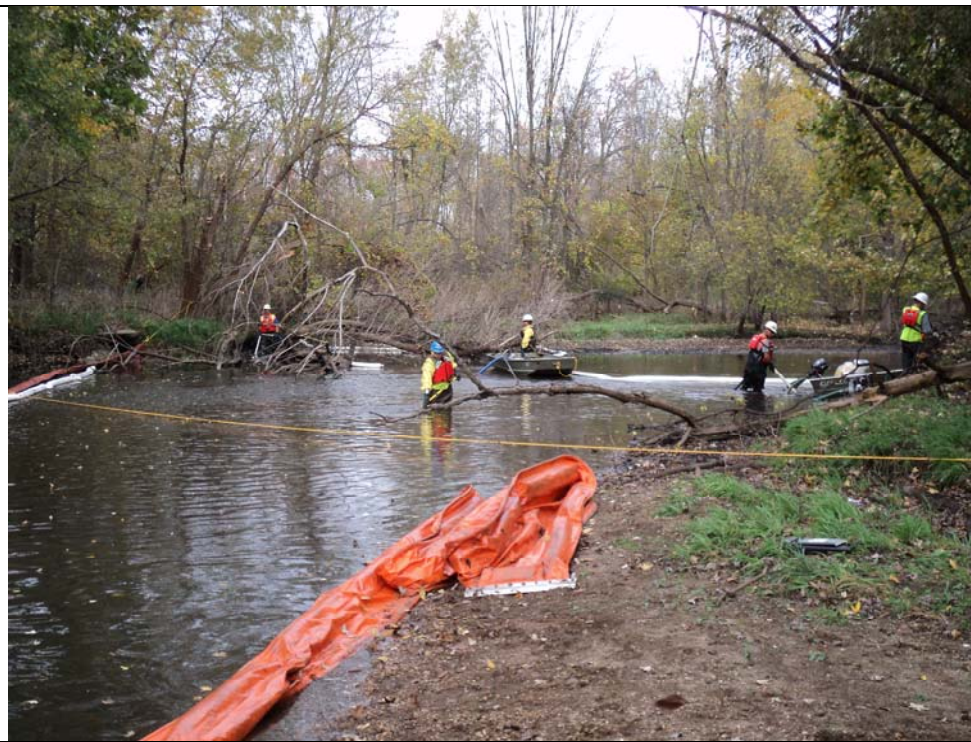
Photograph 2

Raking and water washing activities in progress

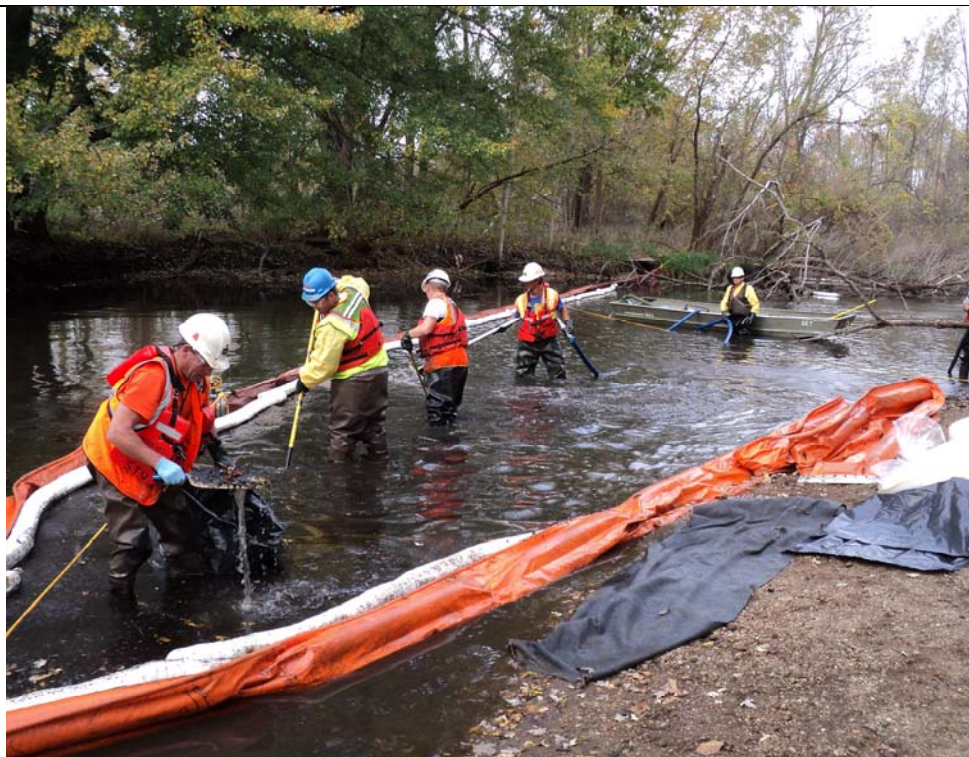
PHOTOGRAPH LOG
Photograph 3

Description:
Recovery activities in progress - raking and water washing

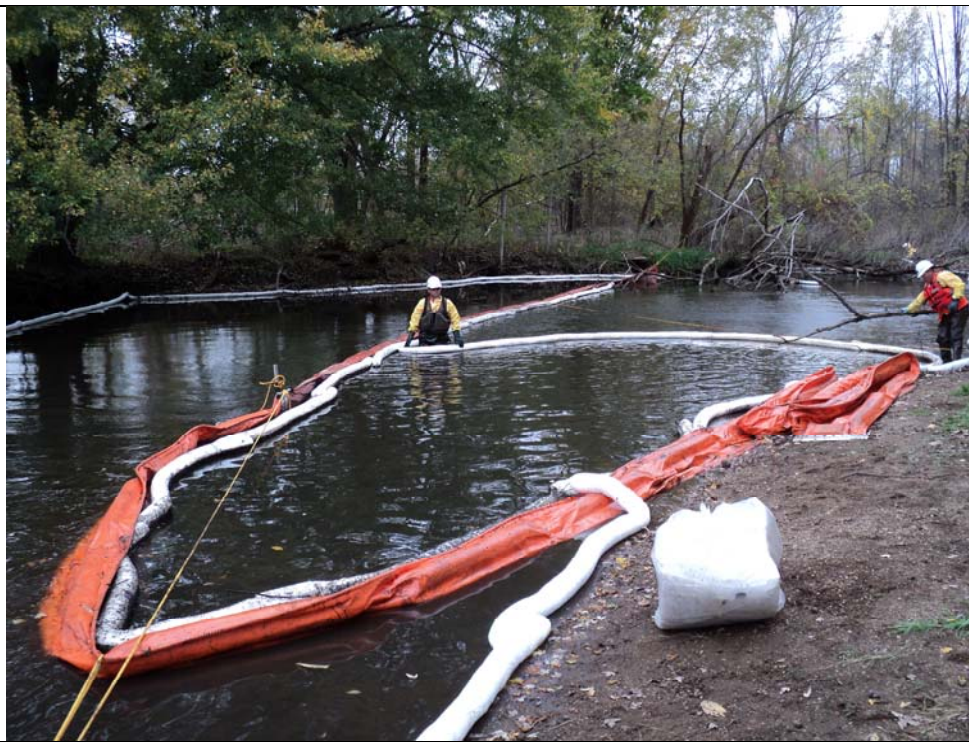
**PHOTOGRAPH LOG**
Photograph 4

Description:
Recovery activities in place - containment structures in place

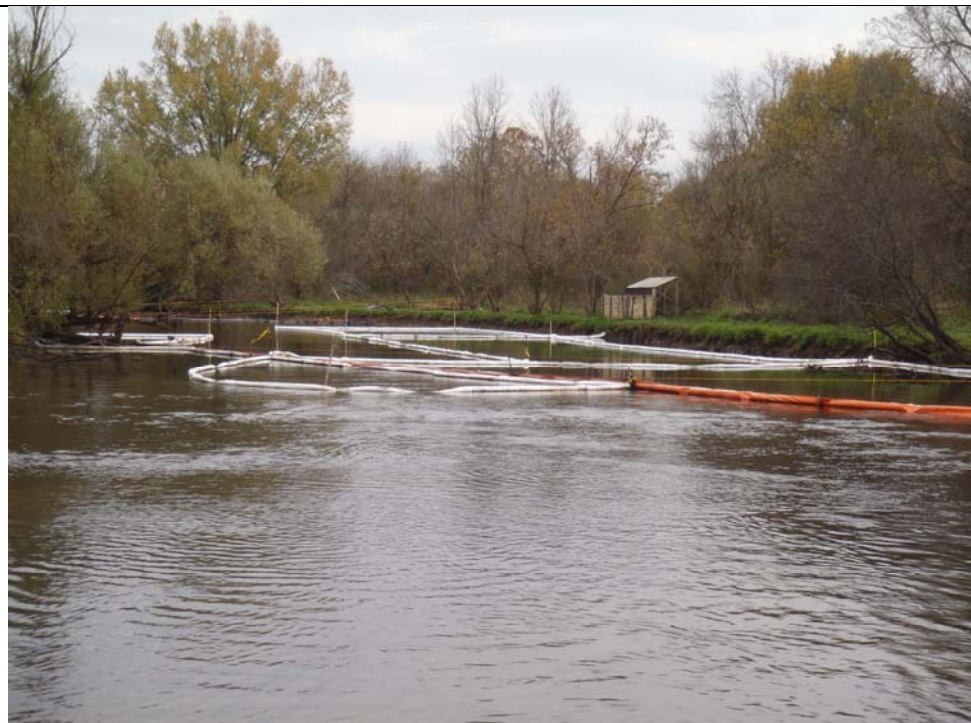
PHOTOGRAPH LOG
Photograph 5

Description:
Recovery activities
complete – containment to
be removed

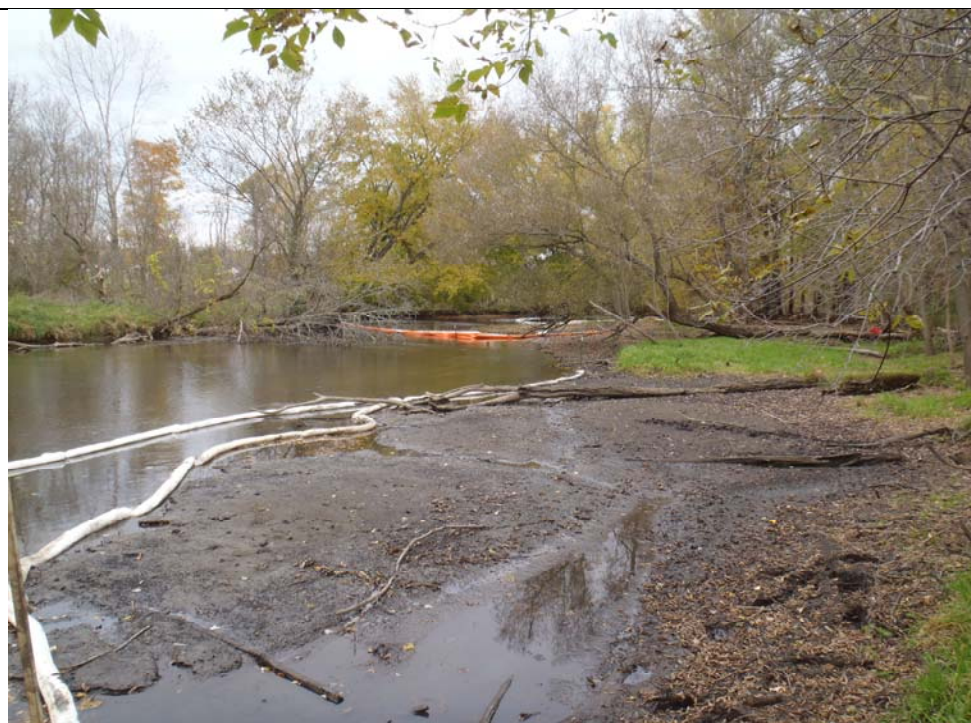
**PHOTOGRAPH LOG**
Photograph 6

Description:
Recovery activities
complete – containment to
be removed

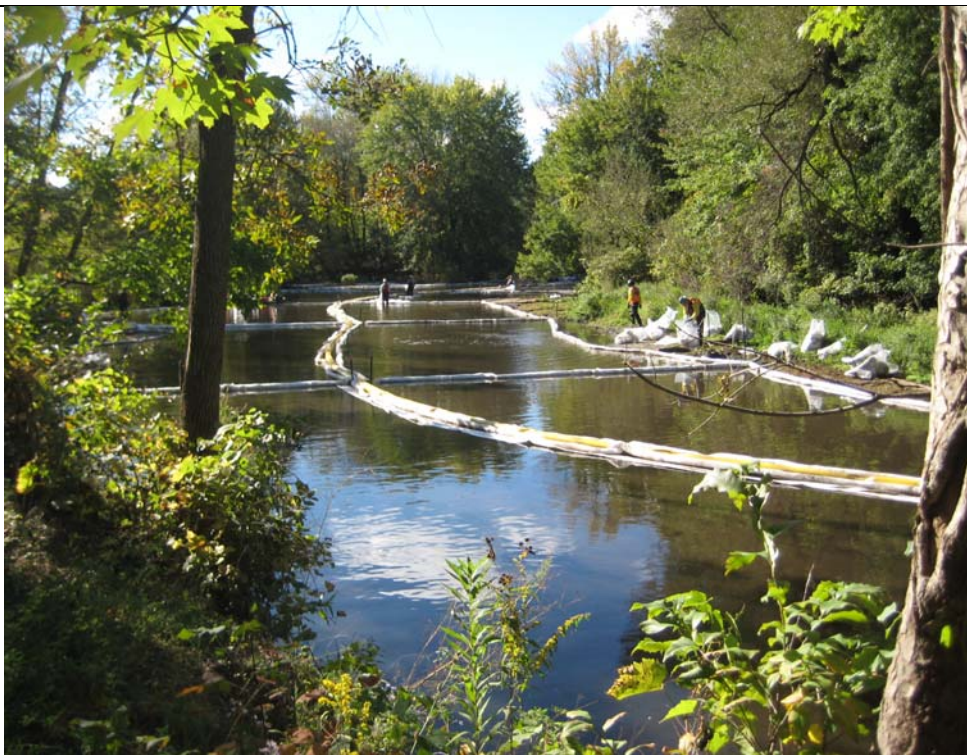
Description:
Recovery activities in progress - Raking and water washing and cell layout

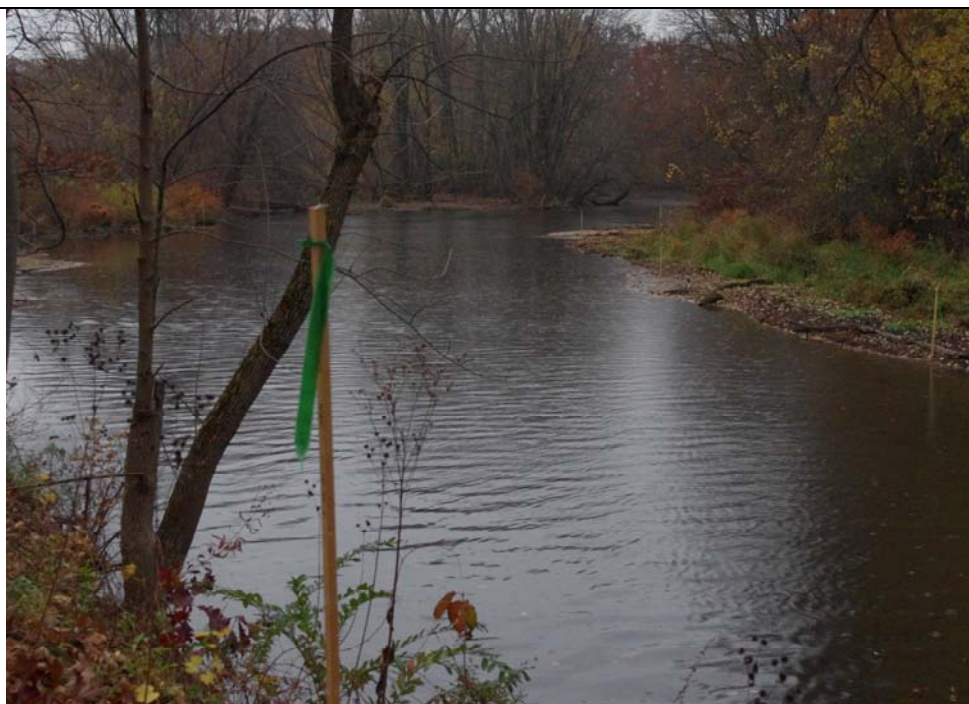
Photograph 4

Description:
Post recovery condition –
recovery activities
complete

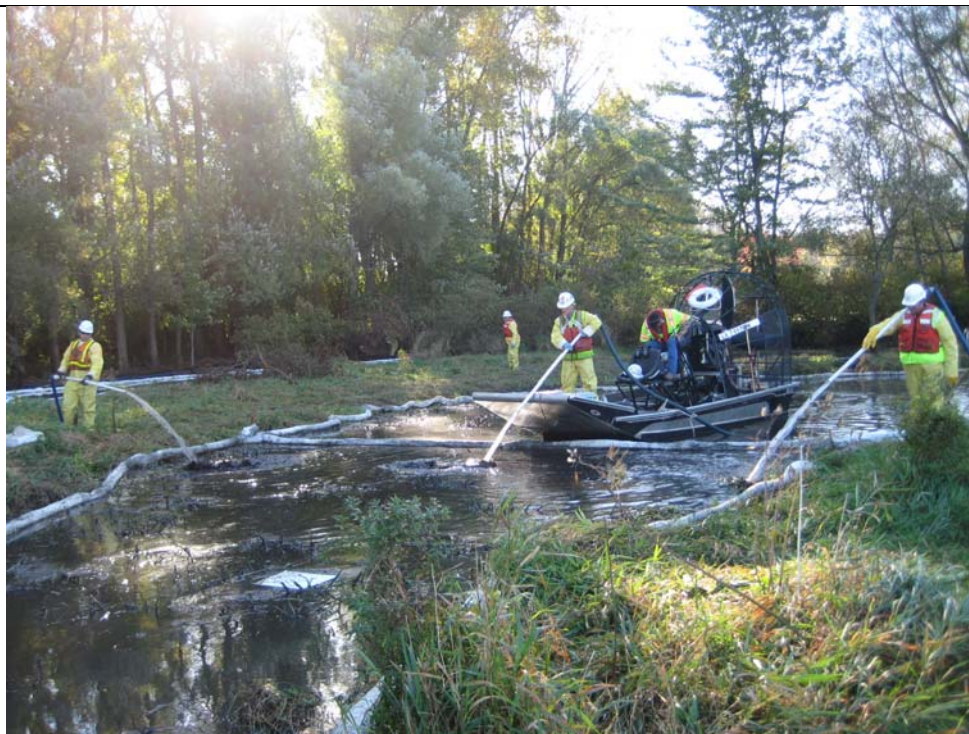
Description:
Recovery in progress –
water washing

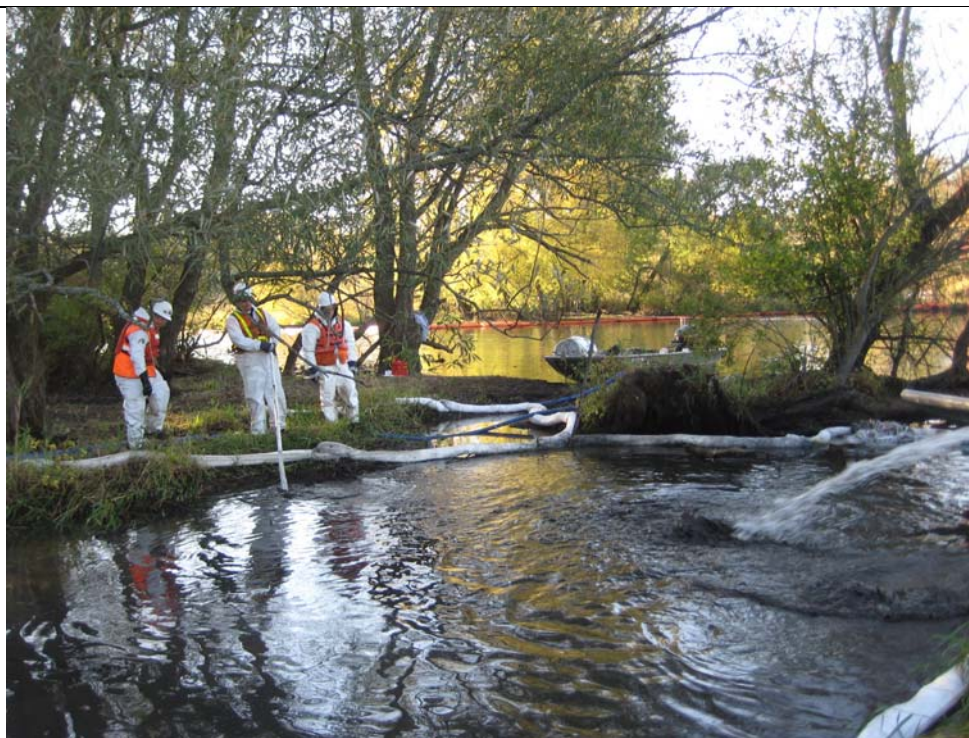
Photograph 2

Water washing
